ARMY RESEARCH LABORATORY

Mechanical Tests and Failure Analysis on Selected Components of the Class 60 Armored Vehicle Launched Bridge (AVLB) During the Class 70 Modification Program

ARL-TR-1269

December 1996

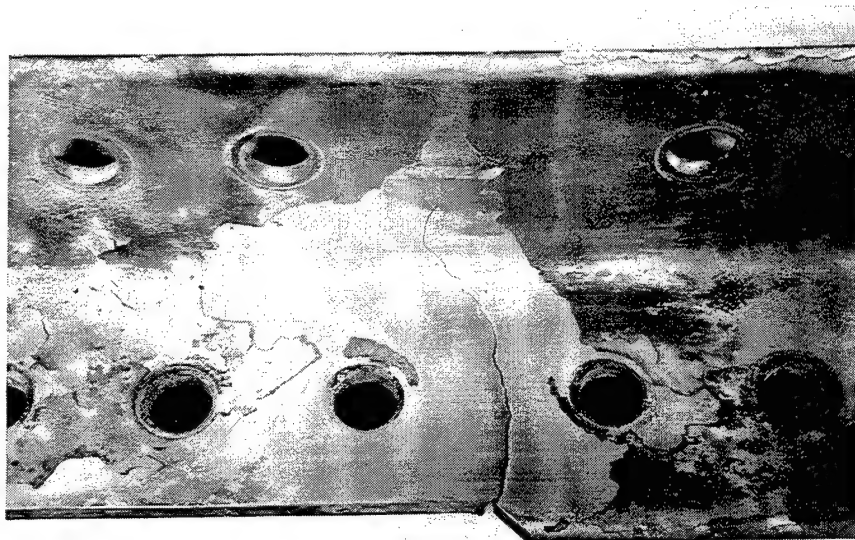
Figure 2. A view of the front side of the cracked inner splice aluminum angle showing the crack, which had initiated at a sharp corner in the angular notch, extending across the horizontal leg and 4/5th of the way up the vertical leg. Note that a portion of the edge was already machined from the leg edge, resulting in an angular notch with a sharp corner that can serve as a stress raiser (stress concentration). Magnification: Approx. 0.4x.

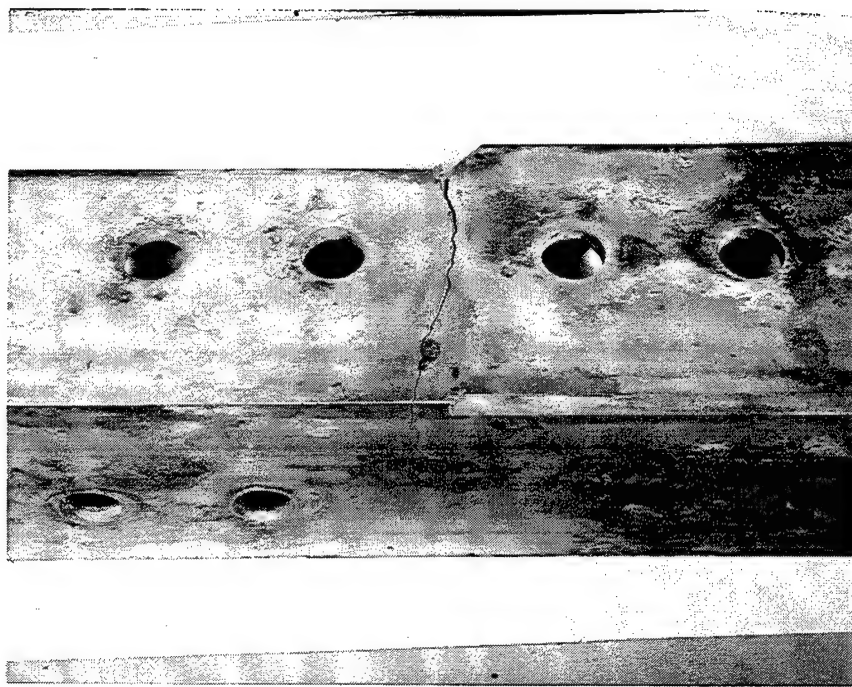
Figure 3. A view of the back side of the same angle in Figure 2. Areas of white corrosion products can be seen on the back sides that were not painted, indicating intrusion of the moisture in the gaps of the spliced joint. Magnification: Approx. 0.4x.

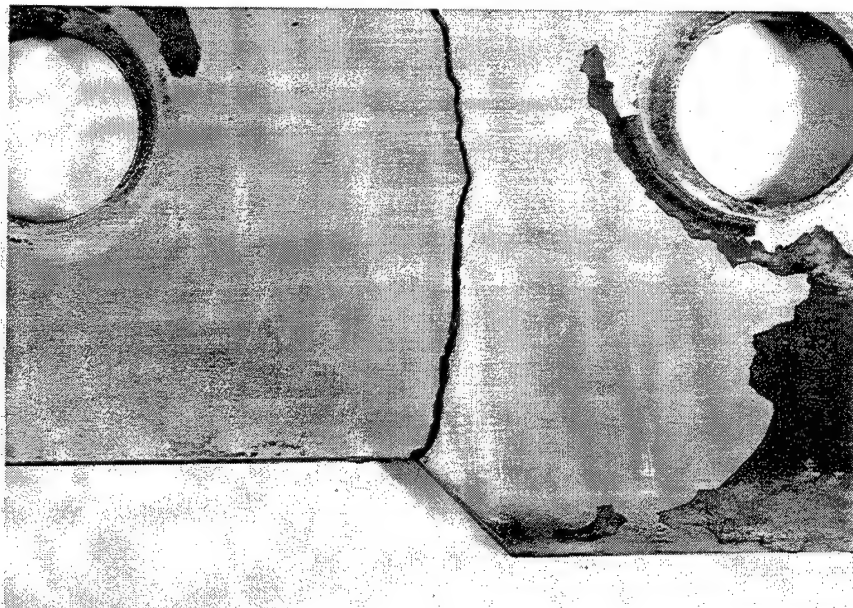
Figure 4. A close-up view of the machined angular notch with a sharp corner that acted as a stress raiser where the crack initiated. Same angle as in Figure 2. Magnification: 1 1/3x.

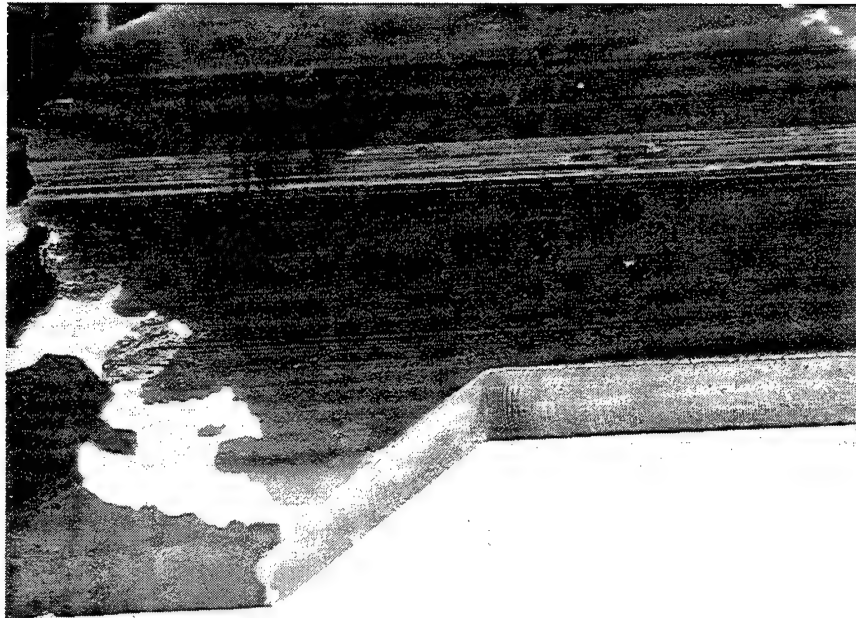
Figure 5. A close-up view of the machined angular notch with a sharp corner in the outer splice angle with no crack. Note the machining of the edge from the angle leg. Magnification: 1 1/3x.

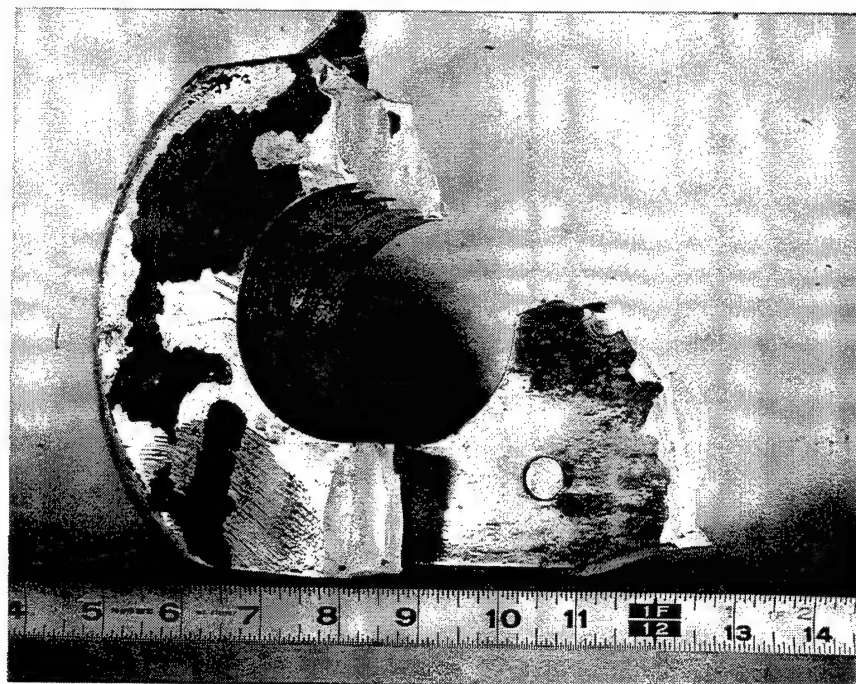
Figure 7. A view of the broken eyehole section from the failed male bottom connector.

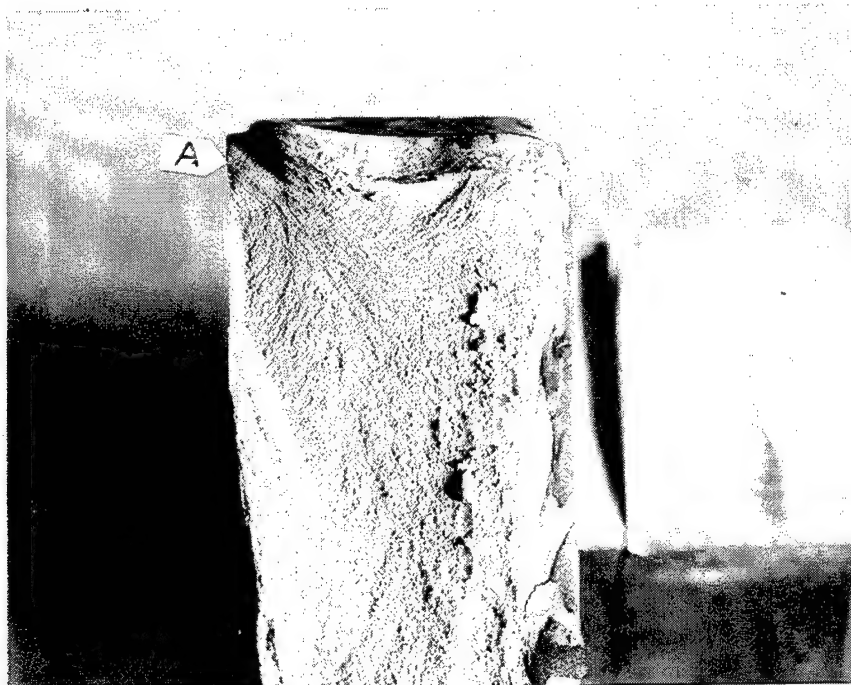
Figure 9. Close-up view of the fracture at location (A) in Figure 8. The features of the fractured surface point toward the failure origin. Magnification: Approx. 1.5 \times .

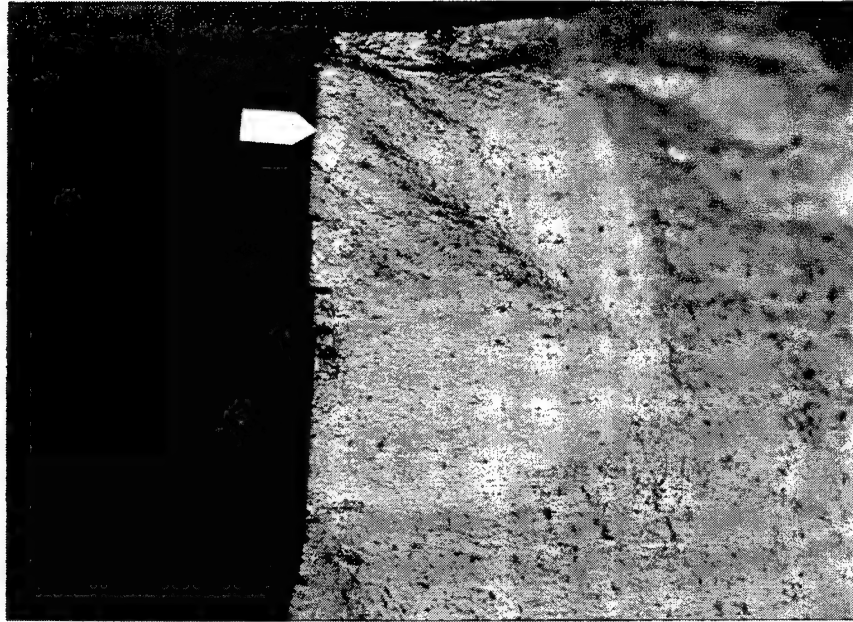
Figure 11. Close-up view of the same area in Figure 10, but at a higher magnification to show smaller fatigue cracks at the edge of the vertical machined sharp notch that cannot be seen in this photograph. Magnification: Approx. 4.3x.

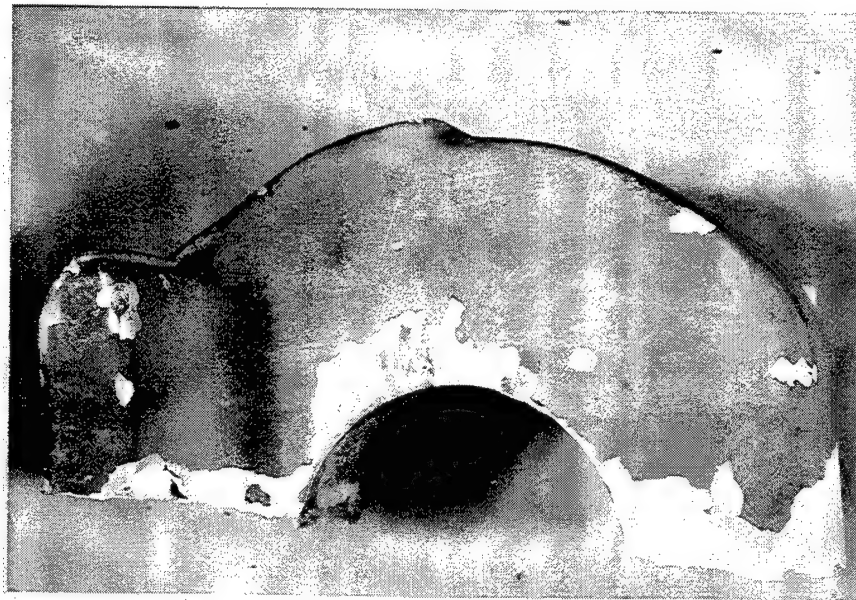
Figure 12. A side view of the broken eyehole section from the failed outboard female bottom connector (outboard forged part). It was removed from a female center panel assembly of the No. 2 Modified AVL B after the bridge's second failure during the fatigue tests. The connector part broke across the 3-in-diameter eyehole for the connector steel pin.

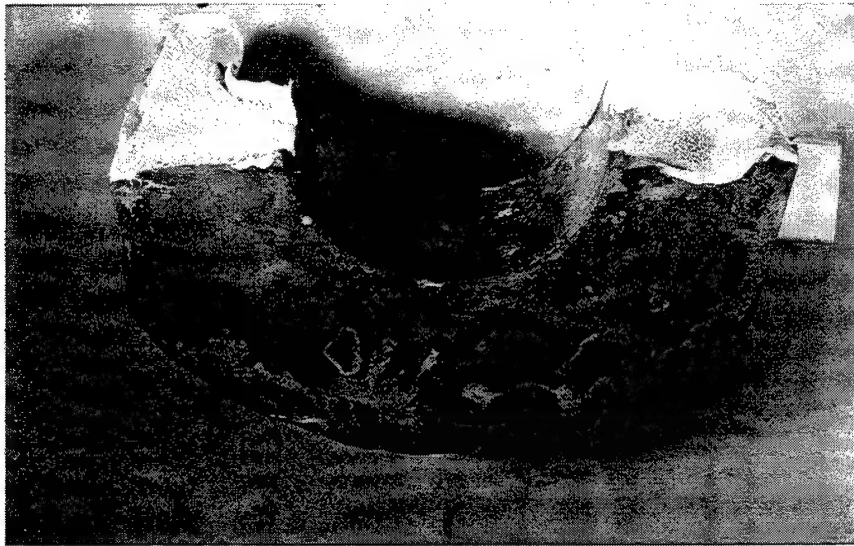
Figure 13. Same broken eyehole section in Figure 12, showing the fractured surfaces.

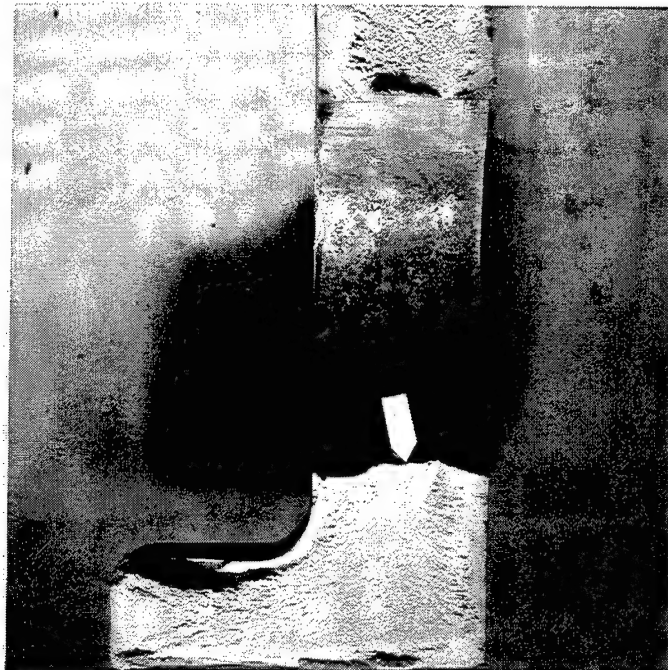
Figure 14. A view of the fractured surfaces of the broken section in Figure 13, showing the location of the failure origin (arrow) at the bottom edge of the 3-in-diameter eyehole. It reveals the characteristic feature of a fatigue crack. Although not clearly seen in the photograph, the corrosion products were observed on the internal bare surface of the eyehole, indicative of corrosion. The eyehole was slightly worn by the steel pin rubbing against it, removing most of the paint to produce bare areas to corrosion.

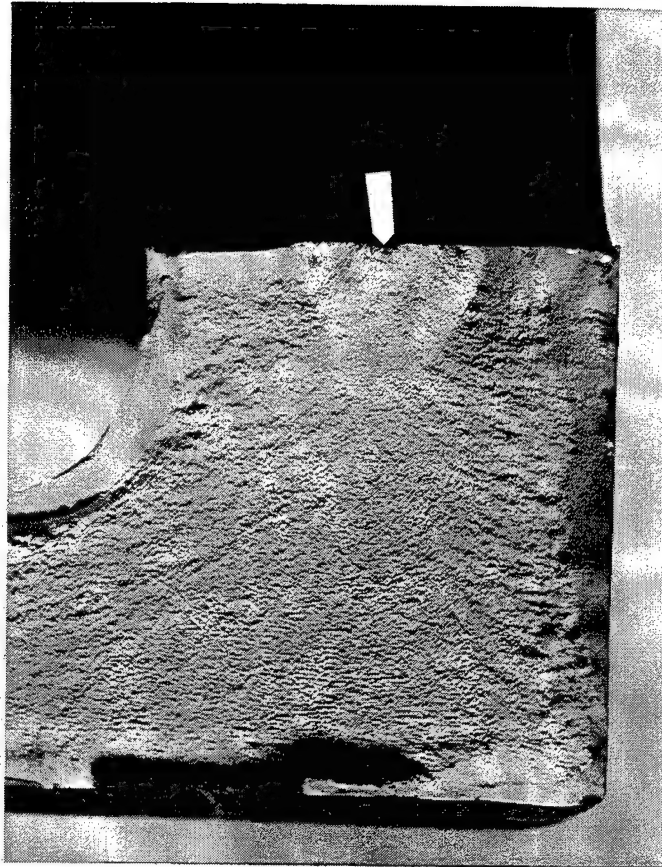
Figure 15. Close-up view of the origin failure (arrow) in Figure 14. Although not clearly seen in the photograph, a small area of discoloration that may be indicative of corrosion was observed in the fatigue crack at the eyehole edge. This was where the fatigue crack had initiated, growing to the critical size during fatigue cyclic loadings to the point of brittle fracture in the forged bottom connector across the eyehole section.

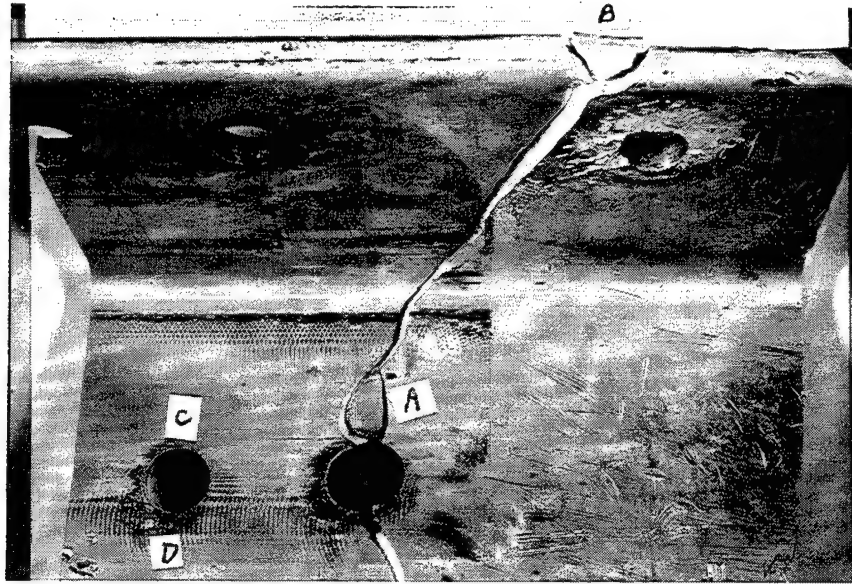
Figure 20. Top view of the broken angle section of the failed bottom chord on the female center panel assembly of the No. 2 Modified AVLB. The crack went across the countersunk rivet hole in the horizontal leg. Note the blackened areas at the edge of the holes in the horizontal leg and along the inside corner of the angle in addition to the outlines of the machined marks from the bottom of the forged center hinge in contact with the top surface of the angle. Two small pieces (A and B) probably broke off during the removal of the broken section. Two small cracks (C and D) were observed 180° apart in the edge of the second rivet hole in the horizontal leg. One-half actual size.

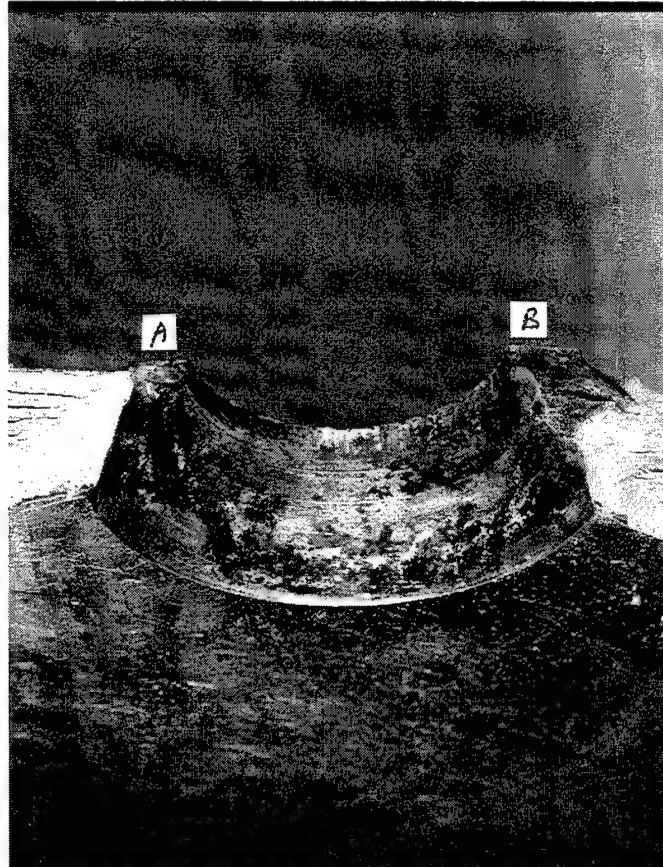
Figure 22. Enlarged view of the fractured countersunk rivet hole in Figure 21, viewing the hole from the bottom surface of the angle. The discolored areas at locations A and B and fatigue beach marks at both corners of the hole were the origin sites of the brittle failure in the bottom chord angle. Magnification: 2.2x.

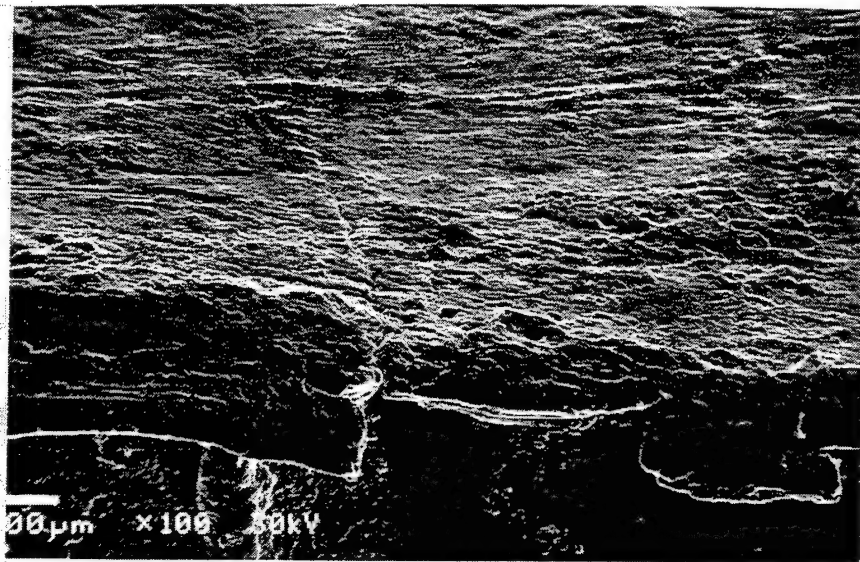
Figure 25. Electron scanning microscope view of the small crack in Figure 24 along the top surface at the hole edge of the small-angle piece. Magnification: 100x.

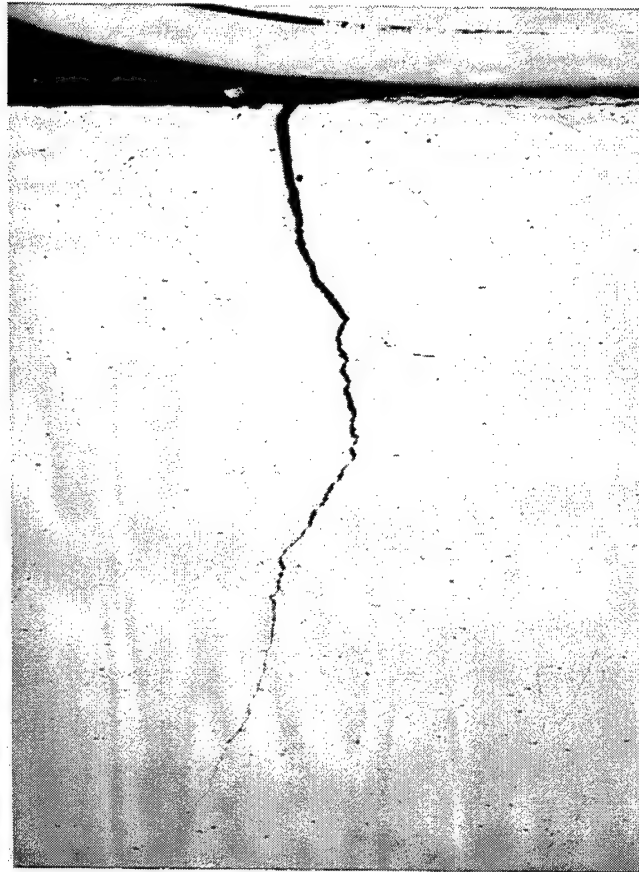
Figure 26. As-polished specimen with the crack seen in the small angle piece in Figure 24. The crack extended from the top surface halfway down the land edge of the countersunk rivet hole. Magnification: 40x.

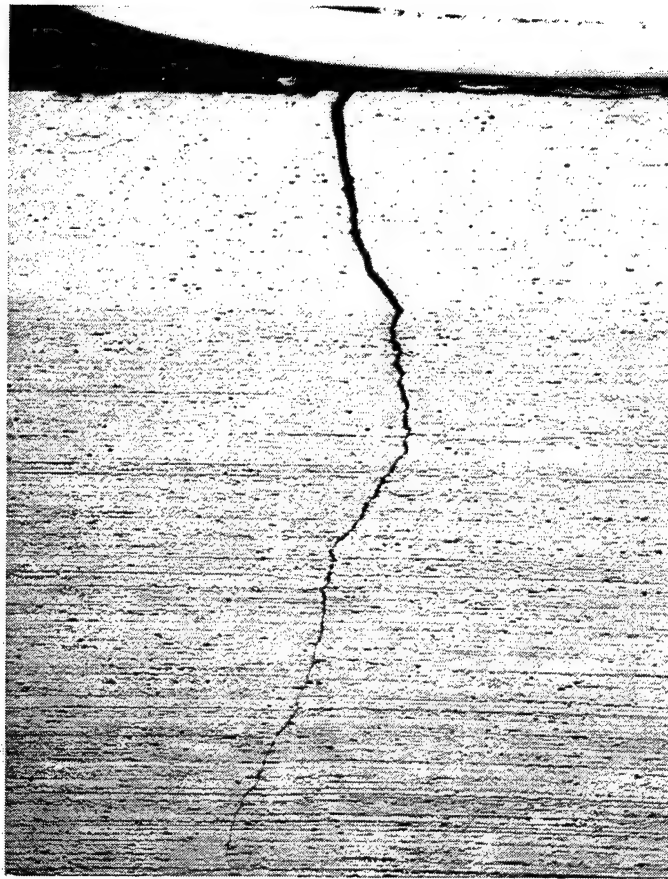
Figure 27. Same area in Figure 26 except etched to reveal the microstructure. The wide light-colored band in the top surface is the recrystallized layer as the result of the angle extrusion process. Magnification: 40 \times . Keller's etchant.

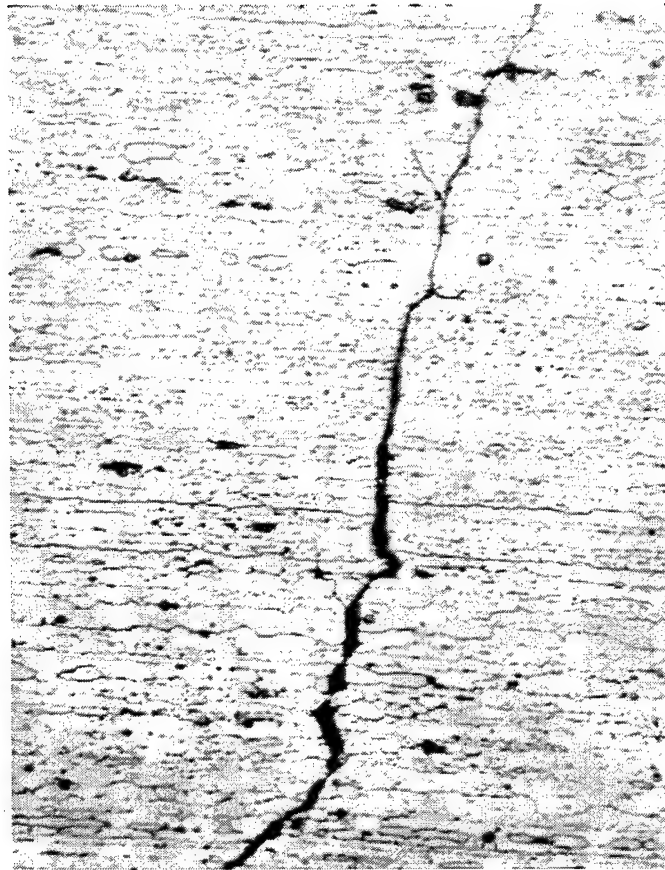
Figure 28. A view of the etched microstructure about 3/4 of the way down the crack in Figure 27. Some branching of the crack is seen. Note that the crack is transgranular since it went across the grains. The grains are elongated as the result of the angle extrusion process. Magnification: 360x.

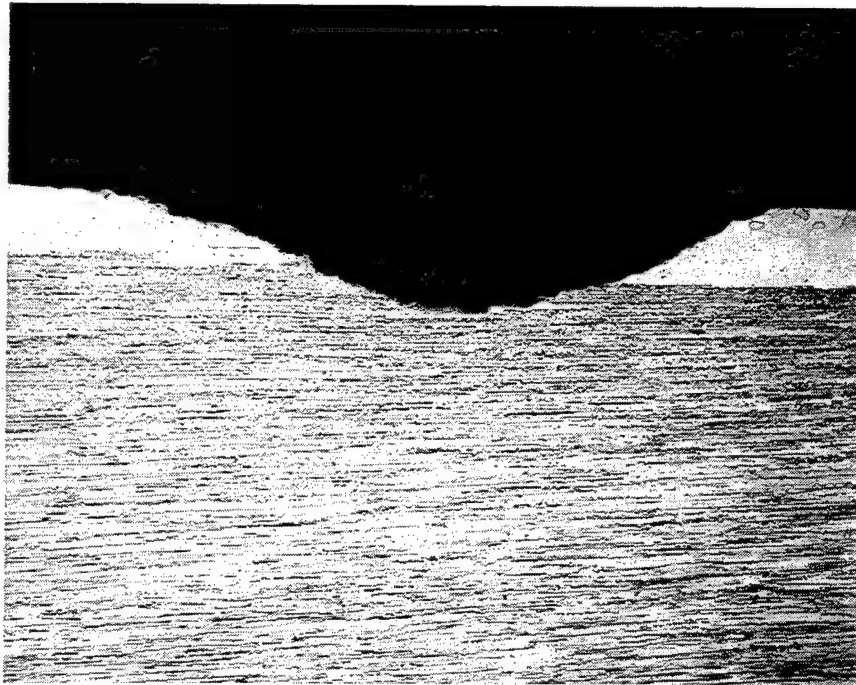
Figure 29. A view of a surface corrosion pit in the top surface of the broken angle. The cross section is through the blackened area in the inside corner of the angle in Figure 20. Magnification: 40x. Keller's etchant.

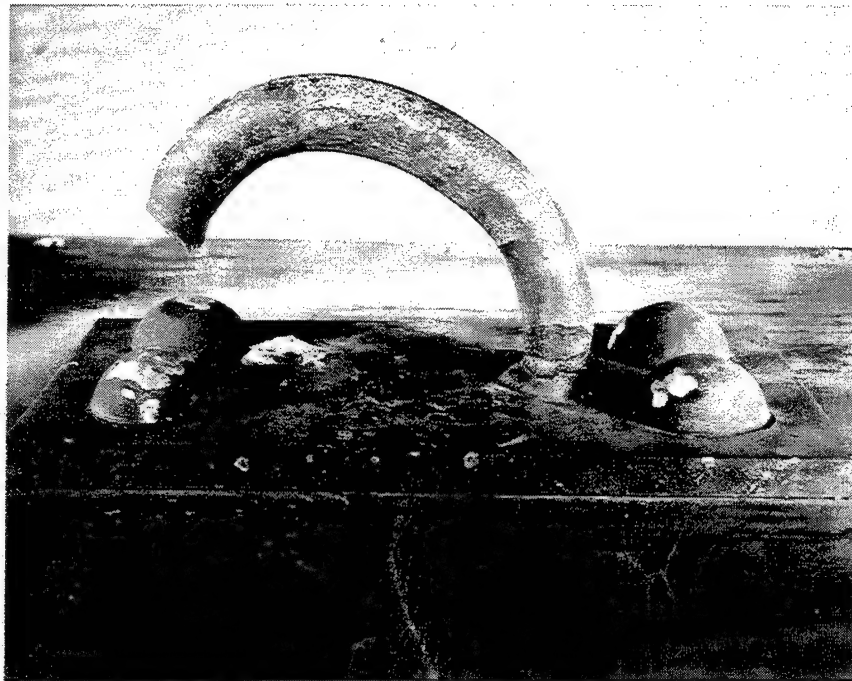
Figure 38. The failure of the AVL B tie-down device after the pull test. The broken end of the steel bar failed under the hook by shearing in the bevel-fillet weld.

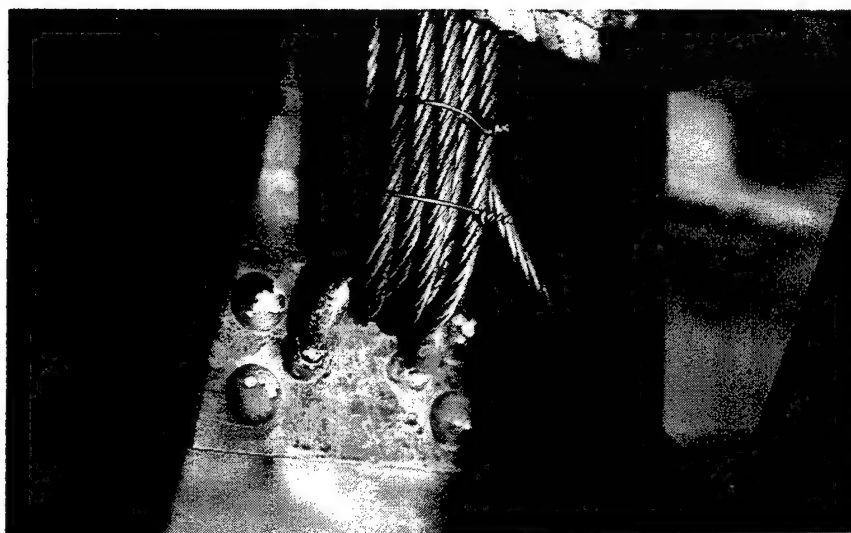
Figure 42. A view of the tie-down device after the pull test to show the mode of the failure of the U-shaped bar by bending and cracking at the welded joints.

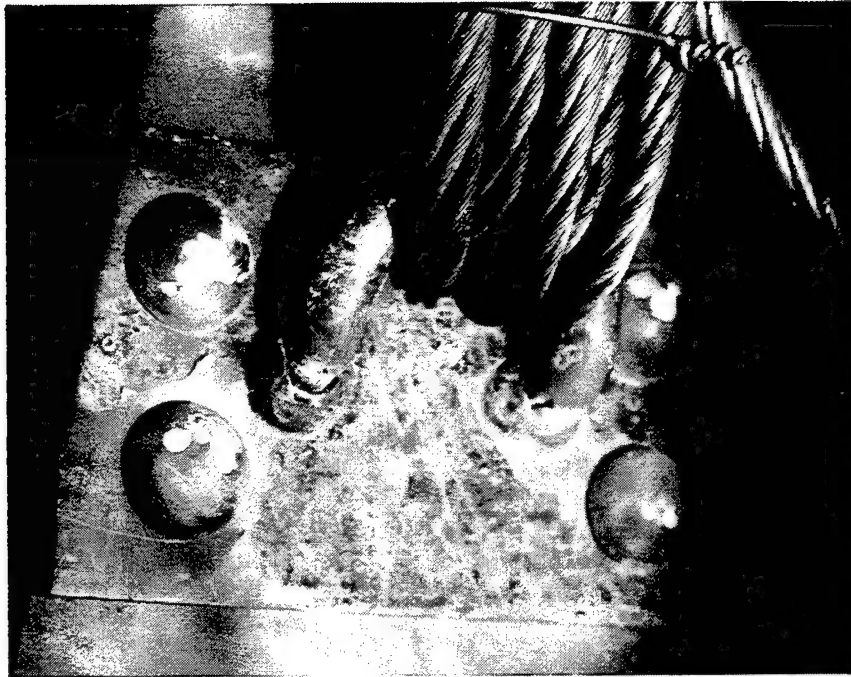
Figure 43. Enlarged view of the failed tie-down device in Figure 42. Note that the failure occurred in the upper toe of both welds.

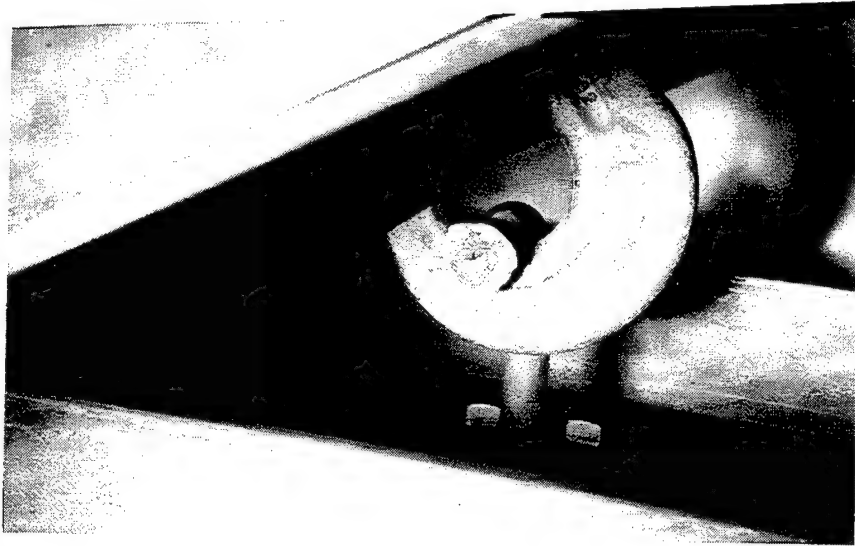
Figure 47. Close-up view of the failed welded end of the U-shaped bar of the third tie-down device tested after the pull test.

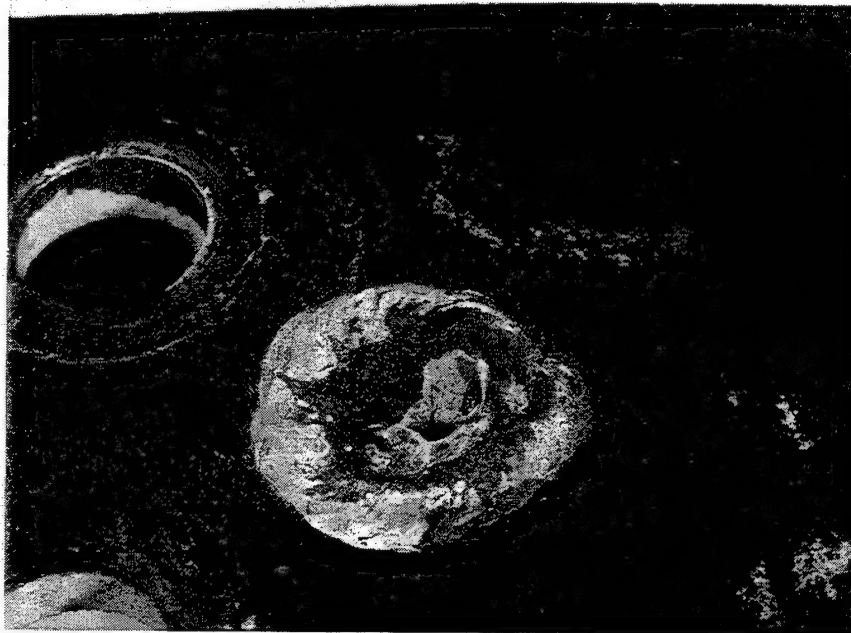
Figure 50. Enlarged view of the weld fracture in the tie-down base plate where the welded end of the bar broke loose.

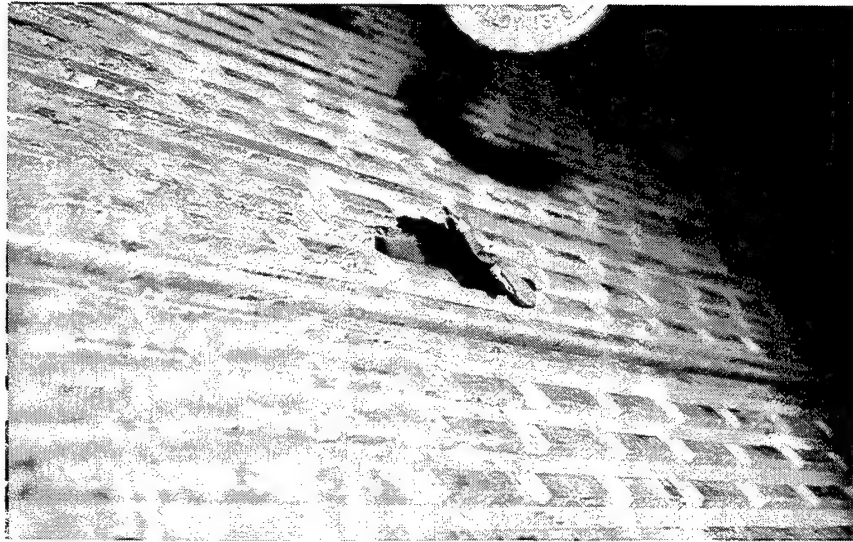
Figure 57. Damage to the oblong hole in the deck panel after the lifting steel bar was pulled out during the first pull test.

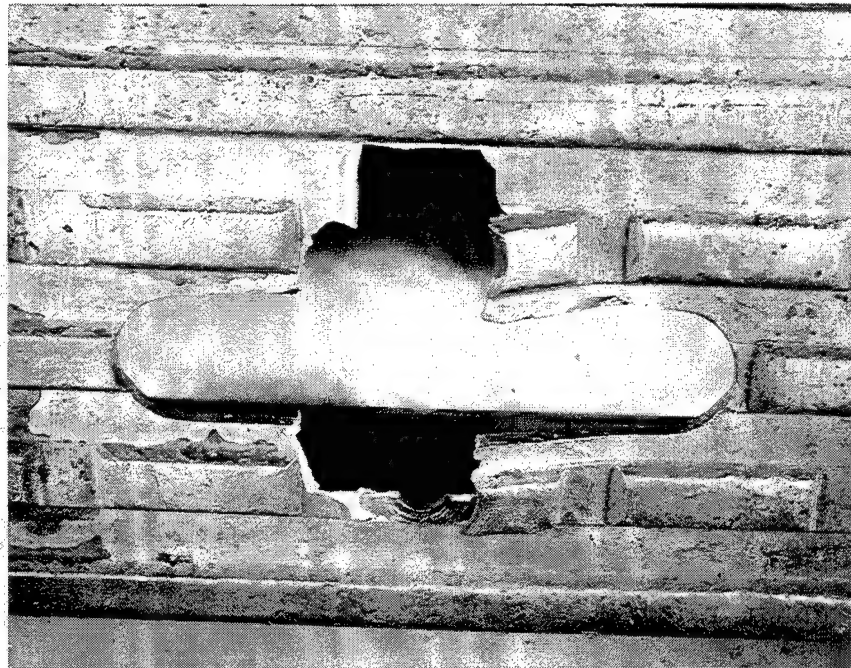
Figure 58. Close-up view of the damaged oblong hole in Figure 57.

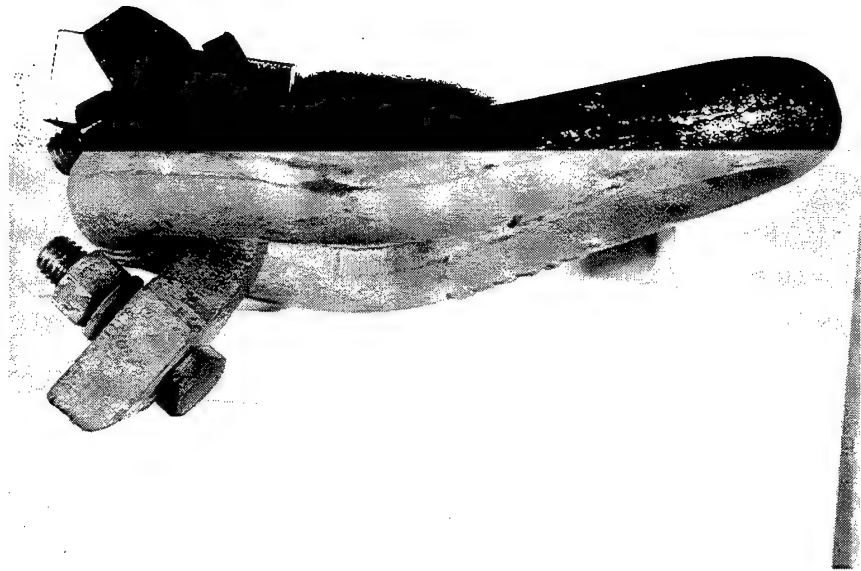
Figure 61. Close-up view of the lifting bar that had bent around the egg-shaped ring during the pull test. Note the 20° offset bend in the ring that had to be bent to be paralleled to the loading axis.

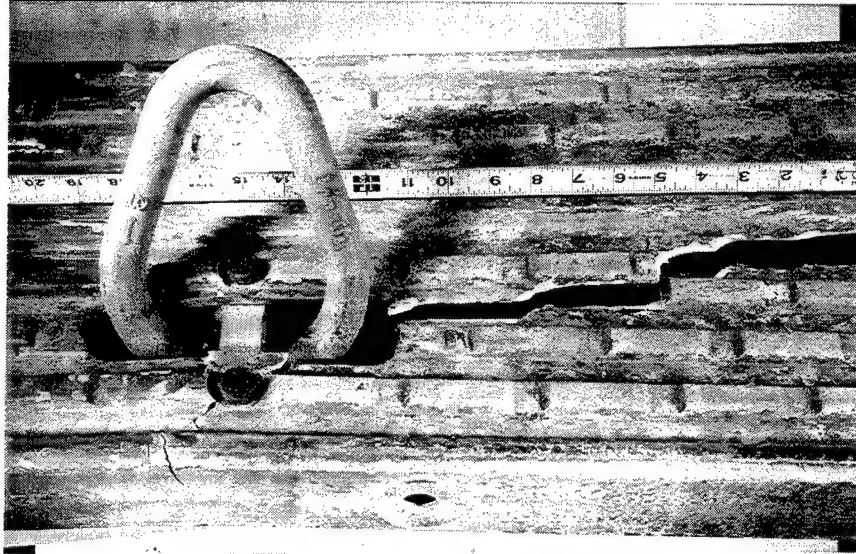
Figure 63. Damages to the extruded aluminum deck panel with the new stronger lifting device bolted to the oblong hole in the panel as the result of the second pull test. Note that the crack started from one end of the oblong hole (right) and continued to the end of the panel (not seen in the photograph). Also, note the smaller cracks at the lower bolt hole of the oblong hole. The bolt hole was sheared and the crack continued to the edge of the panel. The steel ring was used to pull on the lifting bar in the panel during the test.

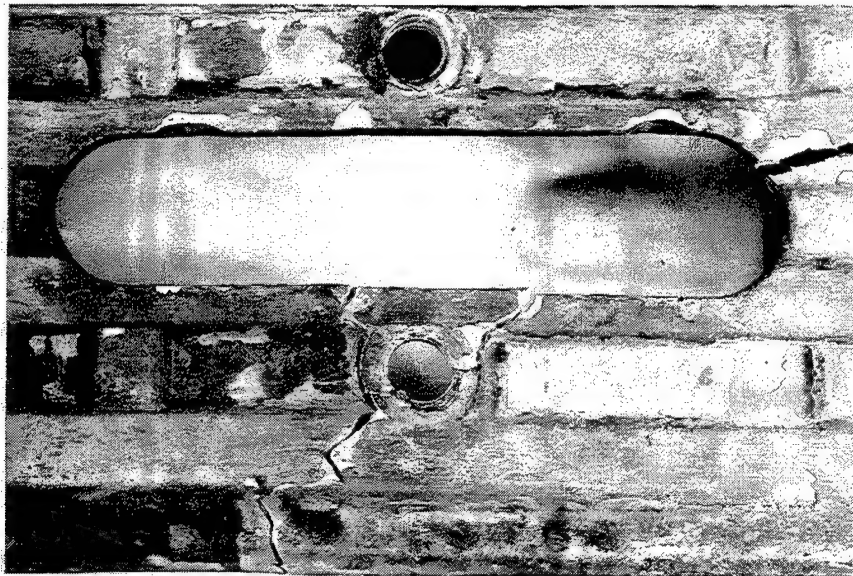
Figure 64. Close-up view of the damaged oblong hole in the deck panel in Figure 63 after the removal of the lifting bar, bolts, and steel ring. Although not clearly seen in the photograph, a small crack was observed in the upper bolt hole.

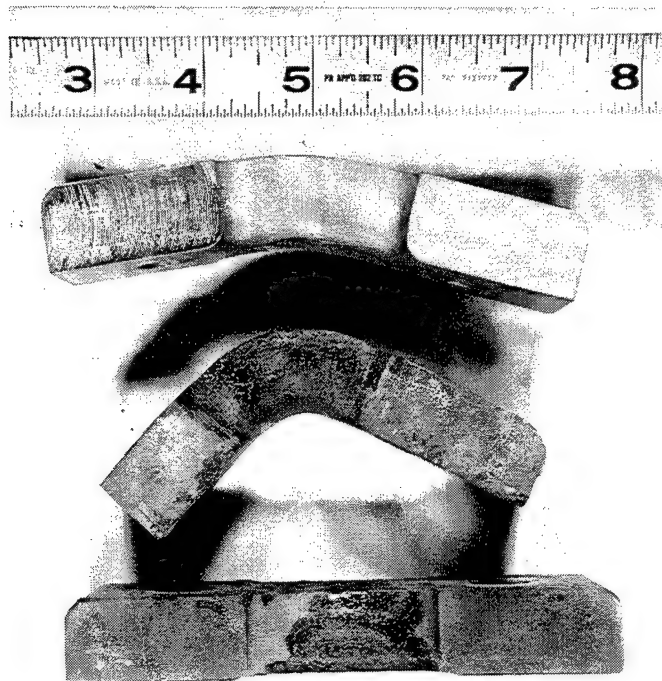
Figure 65. Edge view of the lifting steel bars revealing the extent of bending to the top two bars after the pull tests. The bottom bar served as the reference part that had not been tested for comparison. The middle bar was the original bar made of specified ASTM A 36 structural steel. It was used in the first test that went to 20,250 lb maximum at the time of the failure. The top bar was the new stronger bar made of T-1 steel material. It was used in the second test that went to 28,500 lb maximum at the time of the failure.

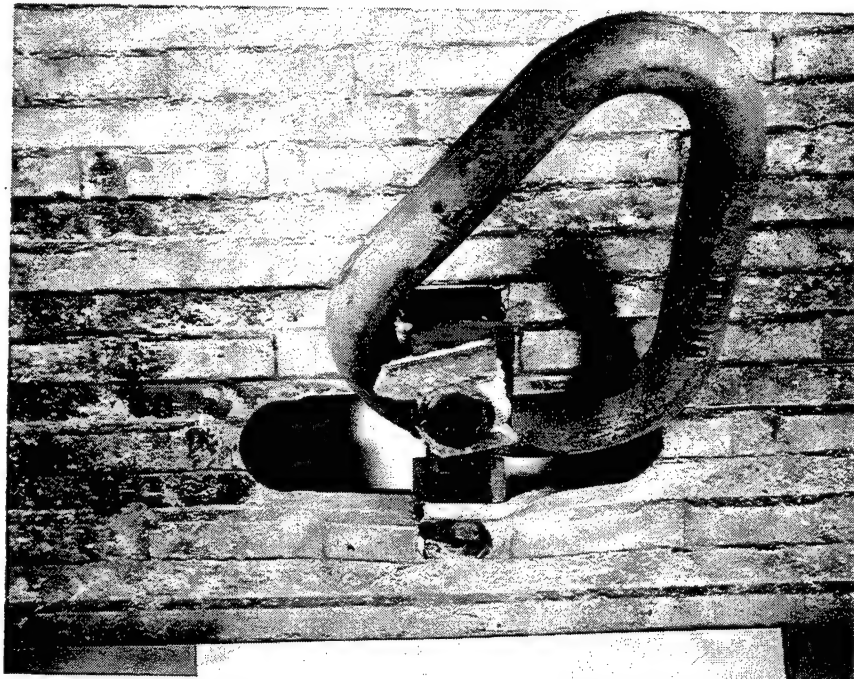
Figure 67. Close-up view of the damaged lifting device at the oblong hole in Figure 66 after removal from the testing machine. Note a small section of the deck panel sheared from the upper edge of the oblong hole, where the final failure of the lifting device occurred.

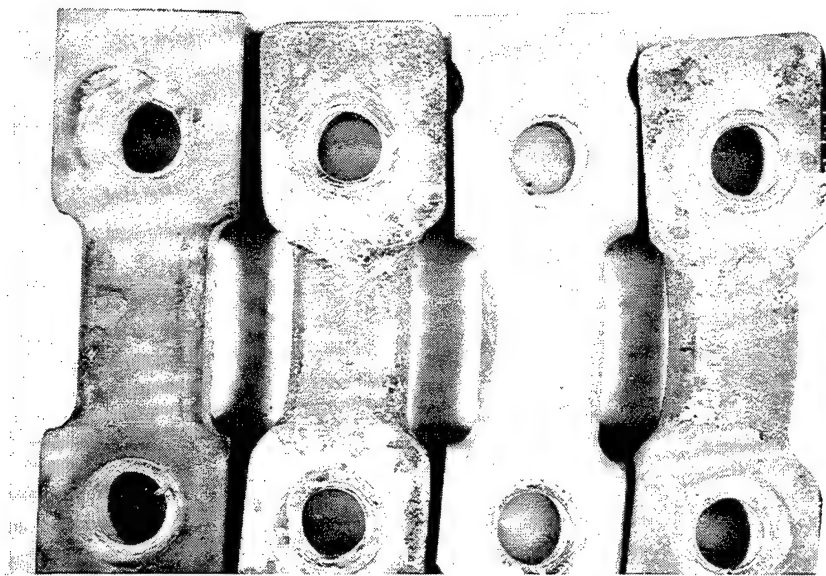
Figure 74. Top view of the lifting steel bar samples after their pull tests. The amounts of bend observed in three samples on the right were compared to the untested straight bar on the left. The first original bar (second from left) was pulled to 20,600 lbs maximum, the stronger bar made from T-1 steel material (third from left) to 39,500 lbs maximum, and the second original bar on right to 30,000 lb. Those three bars were permanently bent horizontally.

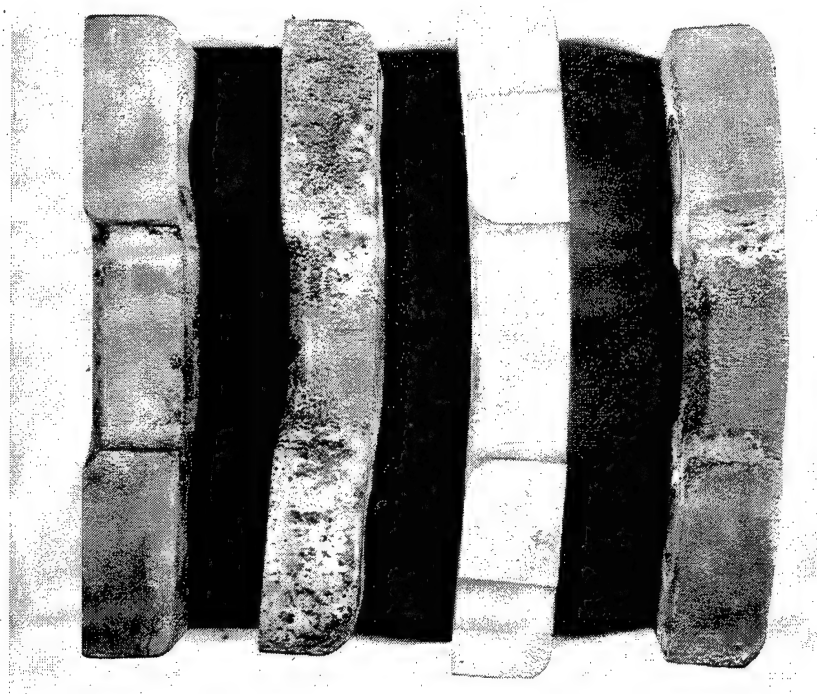
Figure 75. Side view of the same lifting steel bar samples in Figure 74. The three bars on the right were permanently bent vertically.

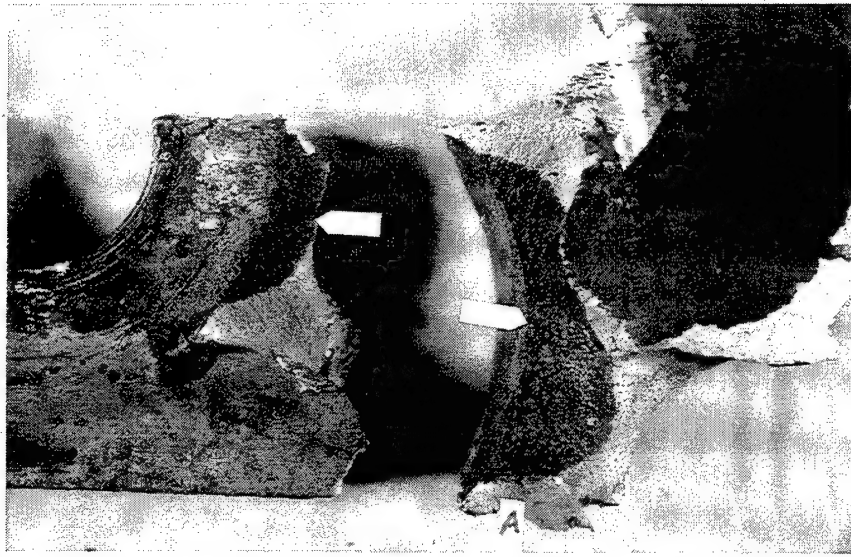
Figure 76. Two small aluminum pieces broken from a 1/2-inch-diameter bolt hole in the AVL B extruded deck panel containing the lifting device that was tested during the first pull test. The arrows point to the matching discolored (dark) areas in the fractured surfaces of both pieces. The curvature seen in the right piece (A) is the wall surface of the counterbore that cut into a protruded tread on the top surface of the deck panel to provide the clearance for the bolt head and socket tool. The pieces are seen in Figures 59 and 60. A small metallographic specimen was cut from the right piece for microstructural examination. Magnification: 2 1/4x.

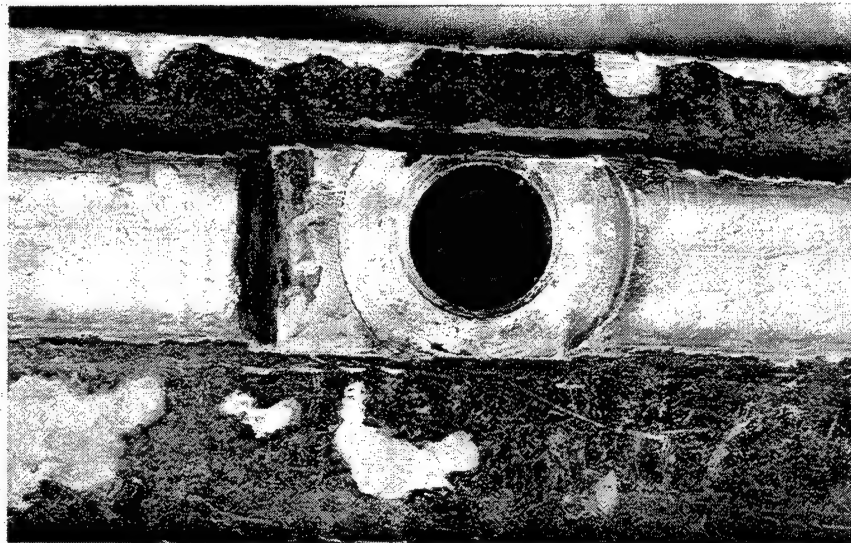
Figure 77. An example of a counterbored bolt hole made on top of the AVL B extruded aluminum deck panel. Note that counterboring had cut into the protruded tread on the right, leaving a sharp fillet at the bottom of the counterbored hole. The fillet can act as a stress raiser for the crack initiation.

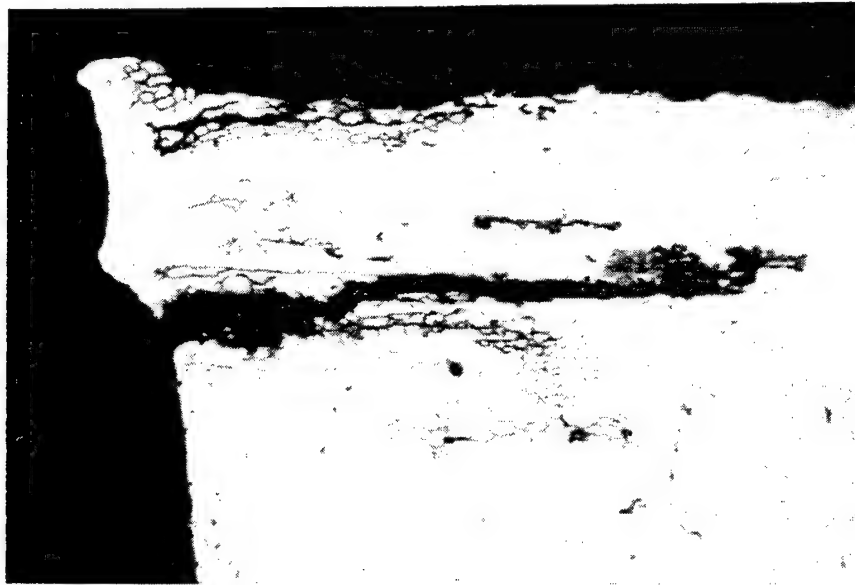
Figure 78. As-polished microstructure showing intergranular corrosion and cracks adjacent to the fracture at top. The vertical side on the left of the microstructure is the wall surface of the counterbore hole, and the slight curvature at the upper left is a portion of the sharp fillet at the bottom of the hole where a crack was initiated because the sharp fillet acted as a stress raiser. Magnification: 380x.

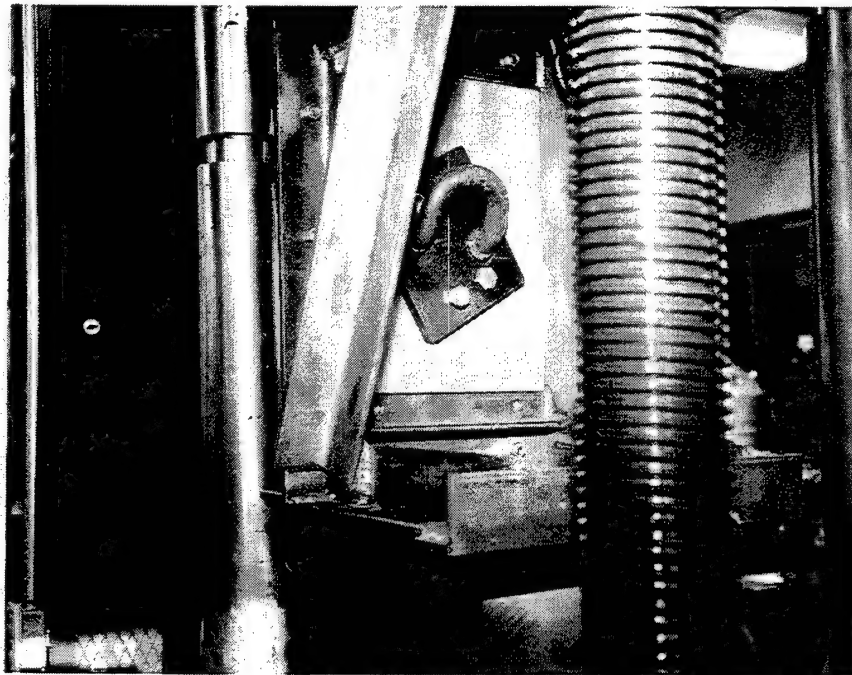
Figure 110. A view of the new lifting device after the perpendicular pull test. Note the extent of damage to the U-shaped bar on the device.

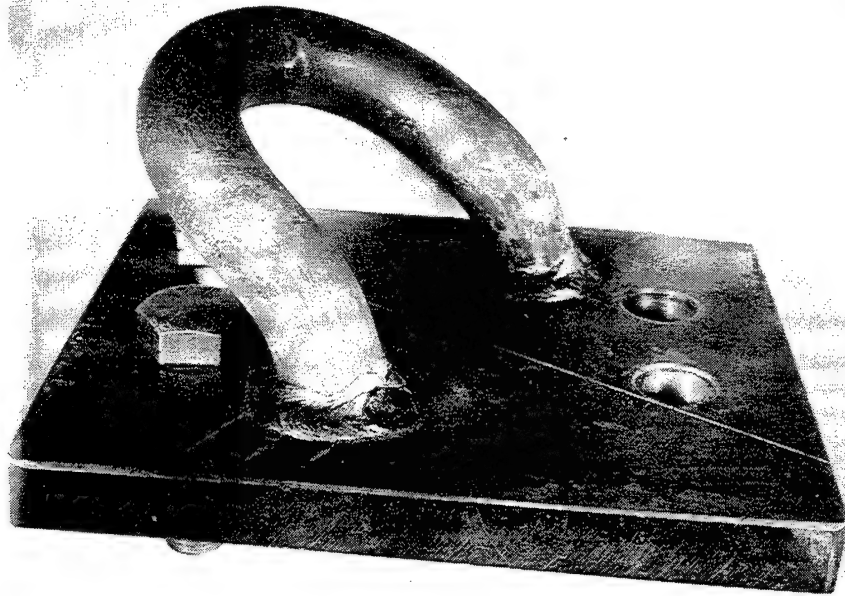
Figure 111. Close-up view of the damaged new lifting device after its removal from the test jig in Figure 110. Although not clearly seen in the photograph, cracks had occurred in the upper toe of the fillet welds on both legs of the U-shaped bar.
